MEMORANDUM

Re: 2017 Sanitary Sewer Maintenance Review

2017 SANITARY SEWER MAINTENANCE

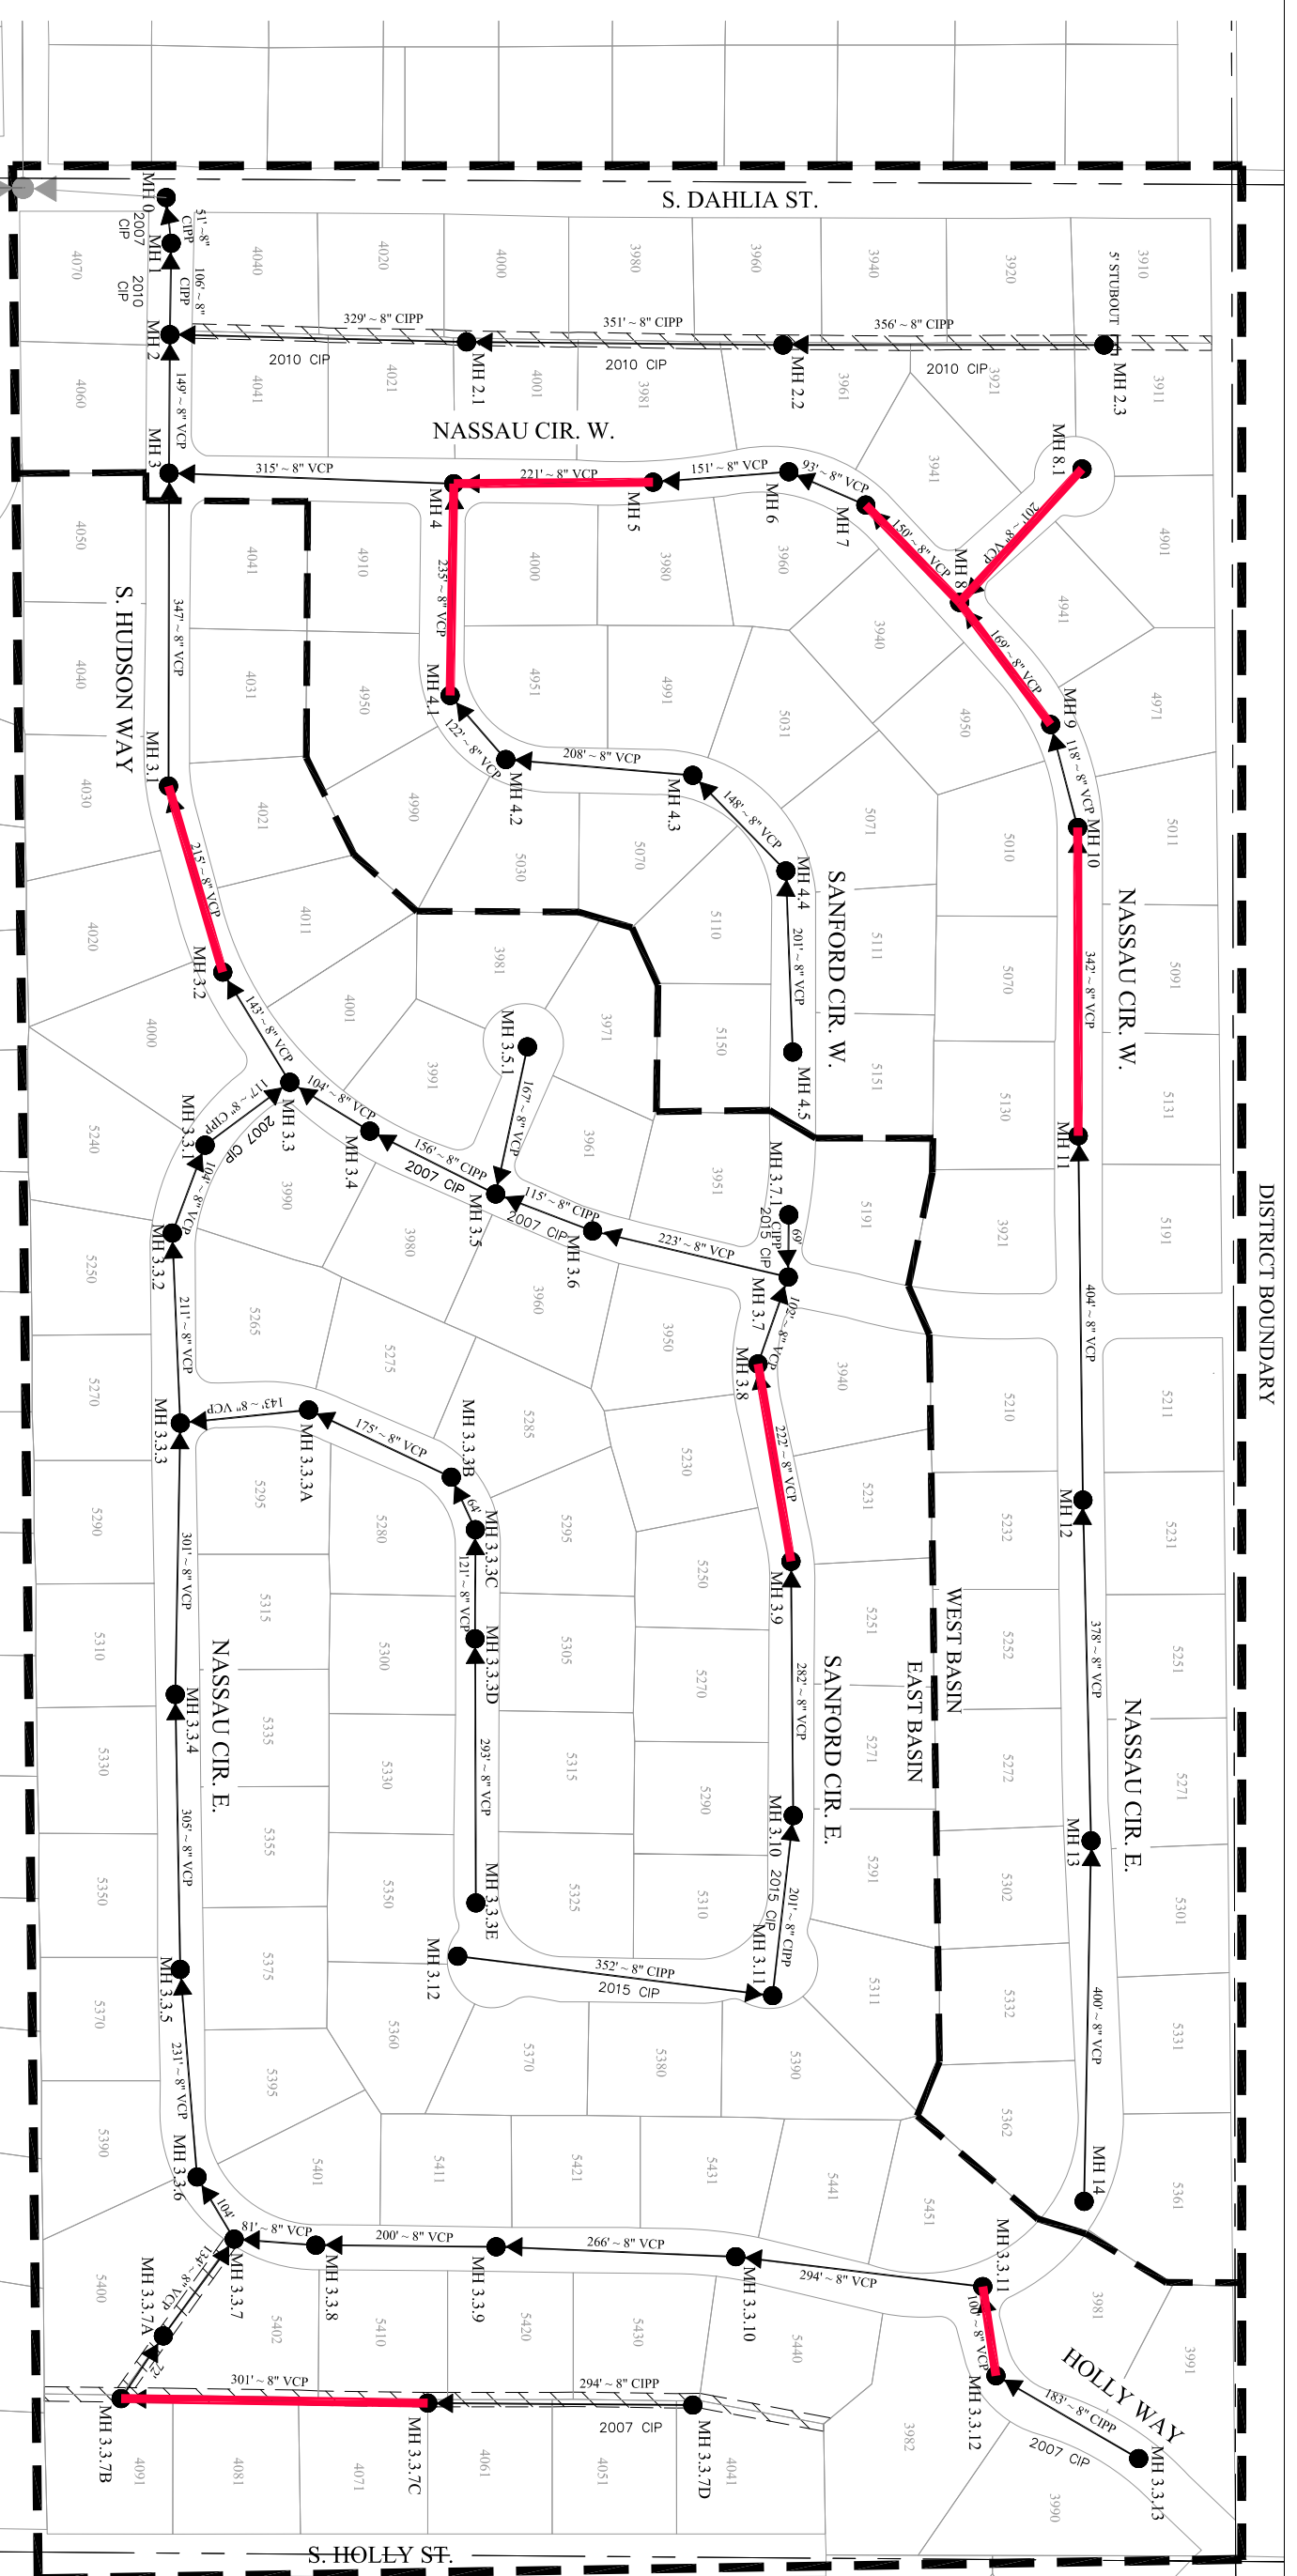
FUTURE
CIPP LINING
EXHIBIT

Two (2) pipe segments have been identified in the 2017 video review as having severe defects that warrant immediate repair. In addition to the eight (8) pipe segments previously identified in 2016, it is our recommendation that all ten (10) pipe segments (2,156 lf) be rehabilitated via cured-in-place pipe. It is also our recommendation that some of the pipe segments be root cut prior to lining. Given the additional root cutting, the estimated cost, based on recent projects with similar scope, is about \$33 / lf or \$71,150 in total.

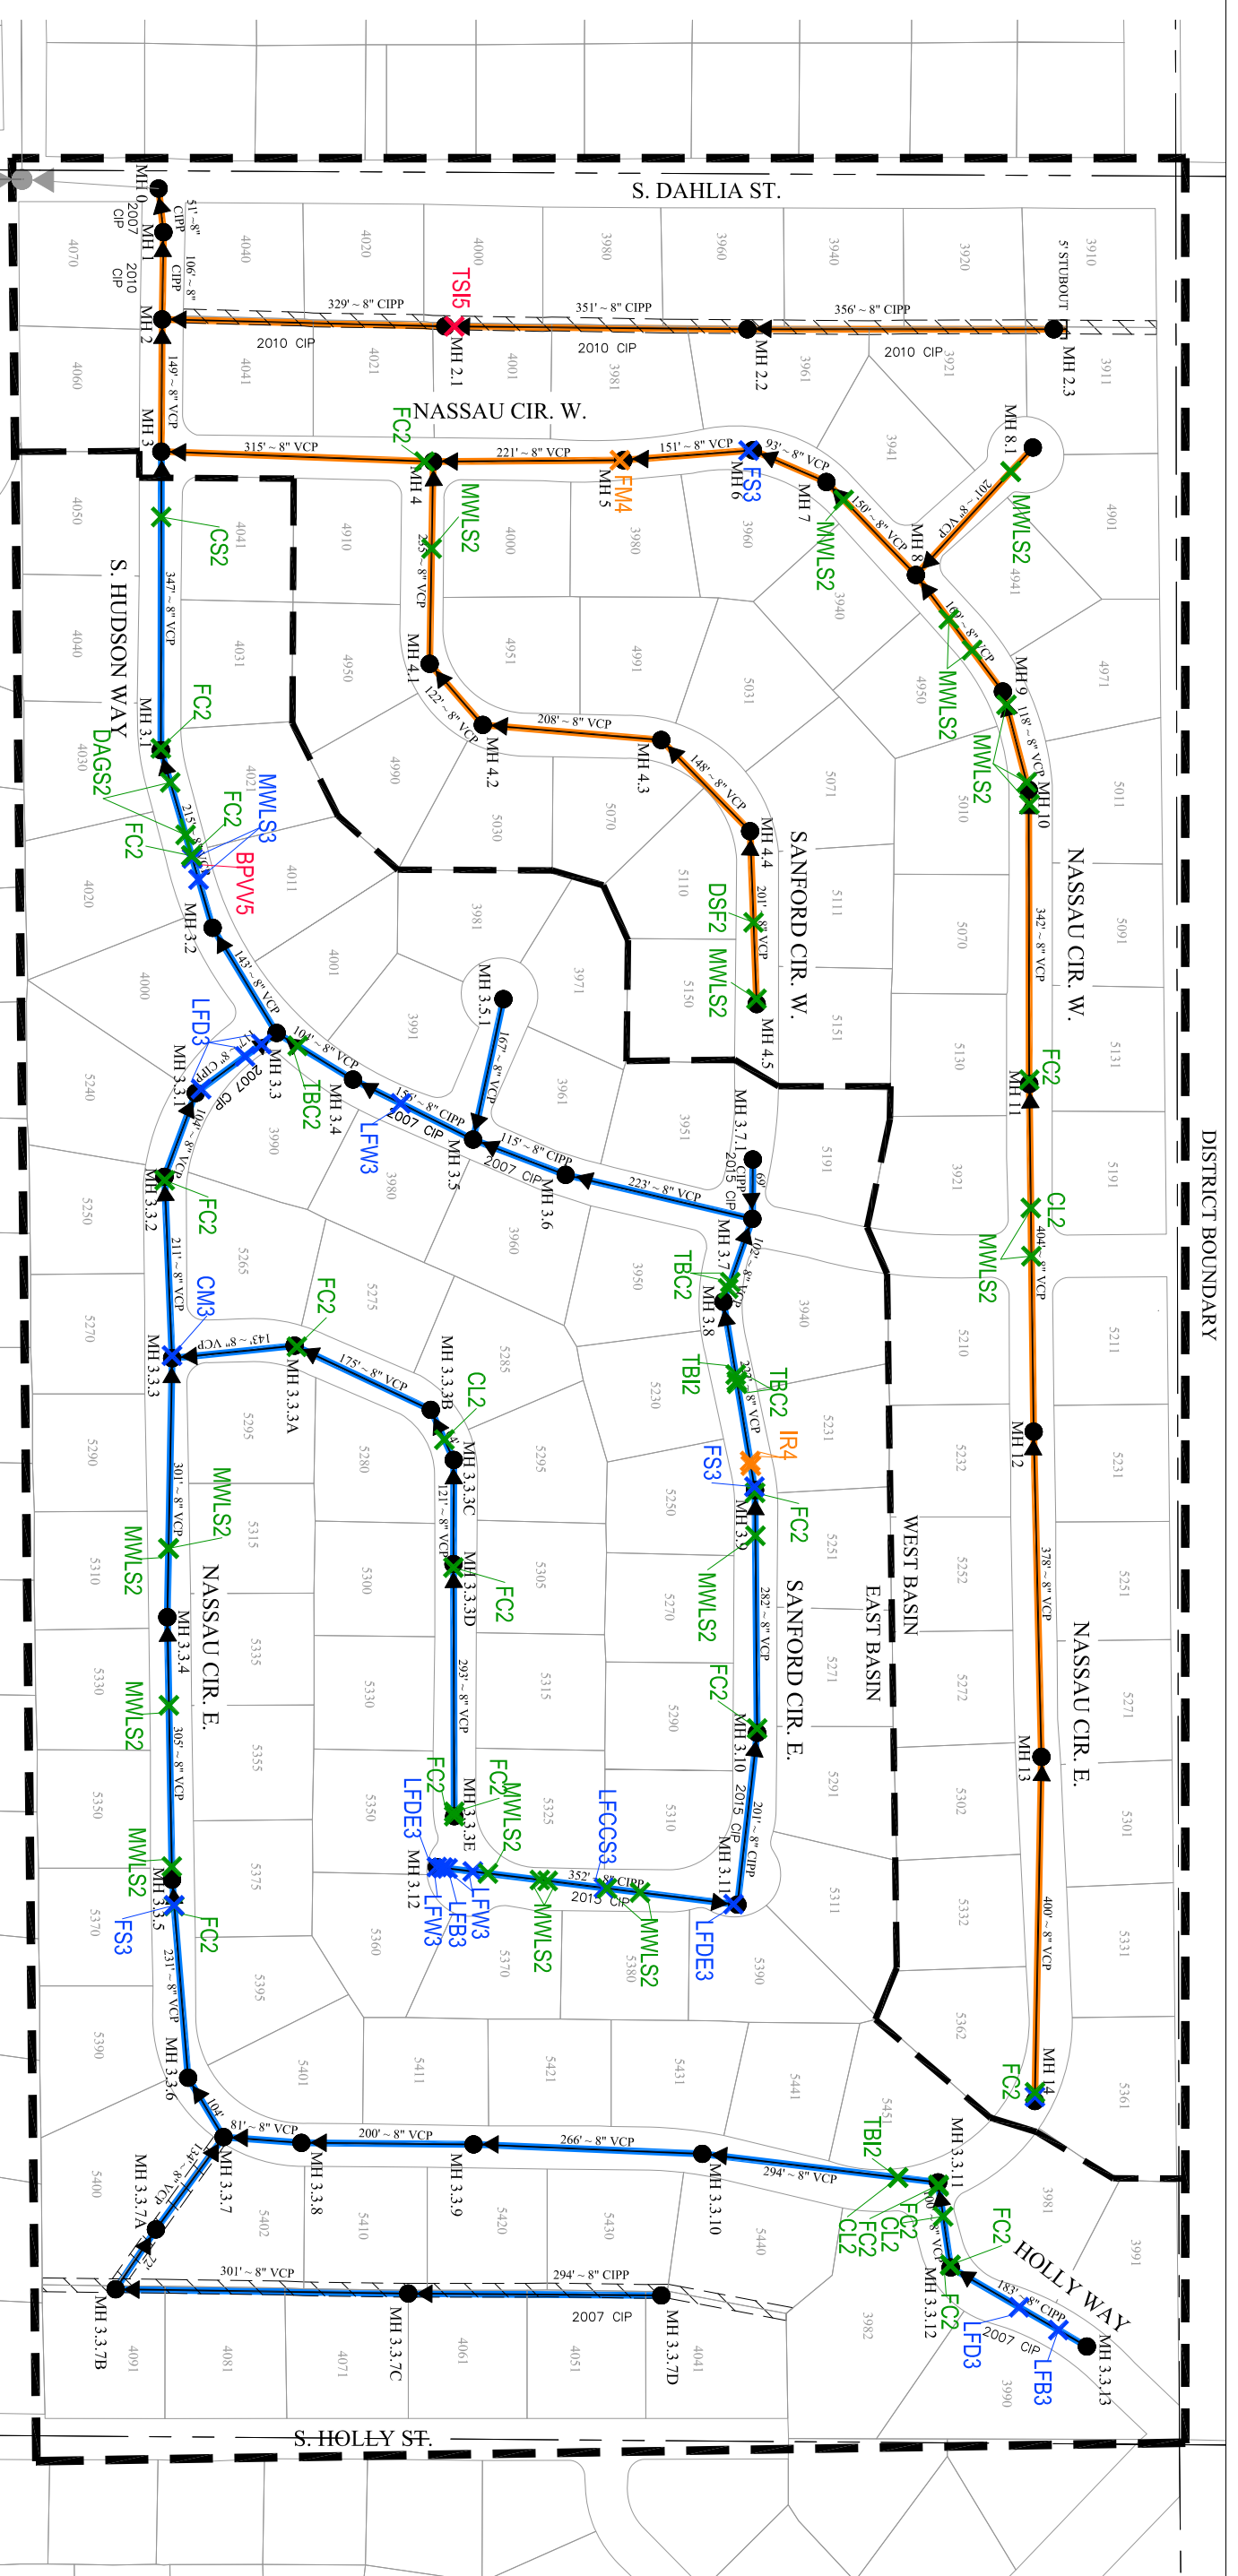
PIPE DEFECTS MAP

- Structural defects with corresponding severity are presented on the attached Pipe Defects Map.
- Roots found with corresponding severity are presented on the attached Roots Map.
