MEMORANDUM

To: Board of Directors
Cherry Hills North Metropolitan District

Re: 2019 Sanitary Sewer Maintenance Program

2018 SANITARY SEWER MAINTENANCE

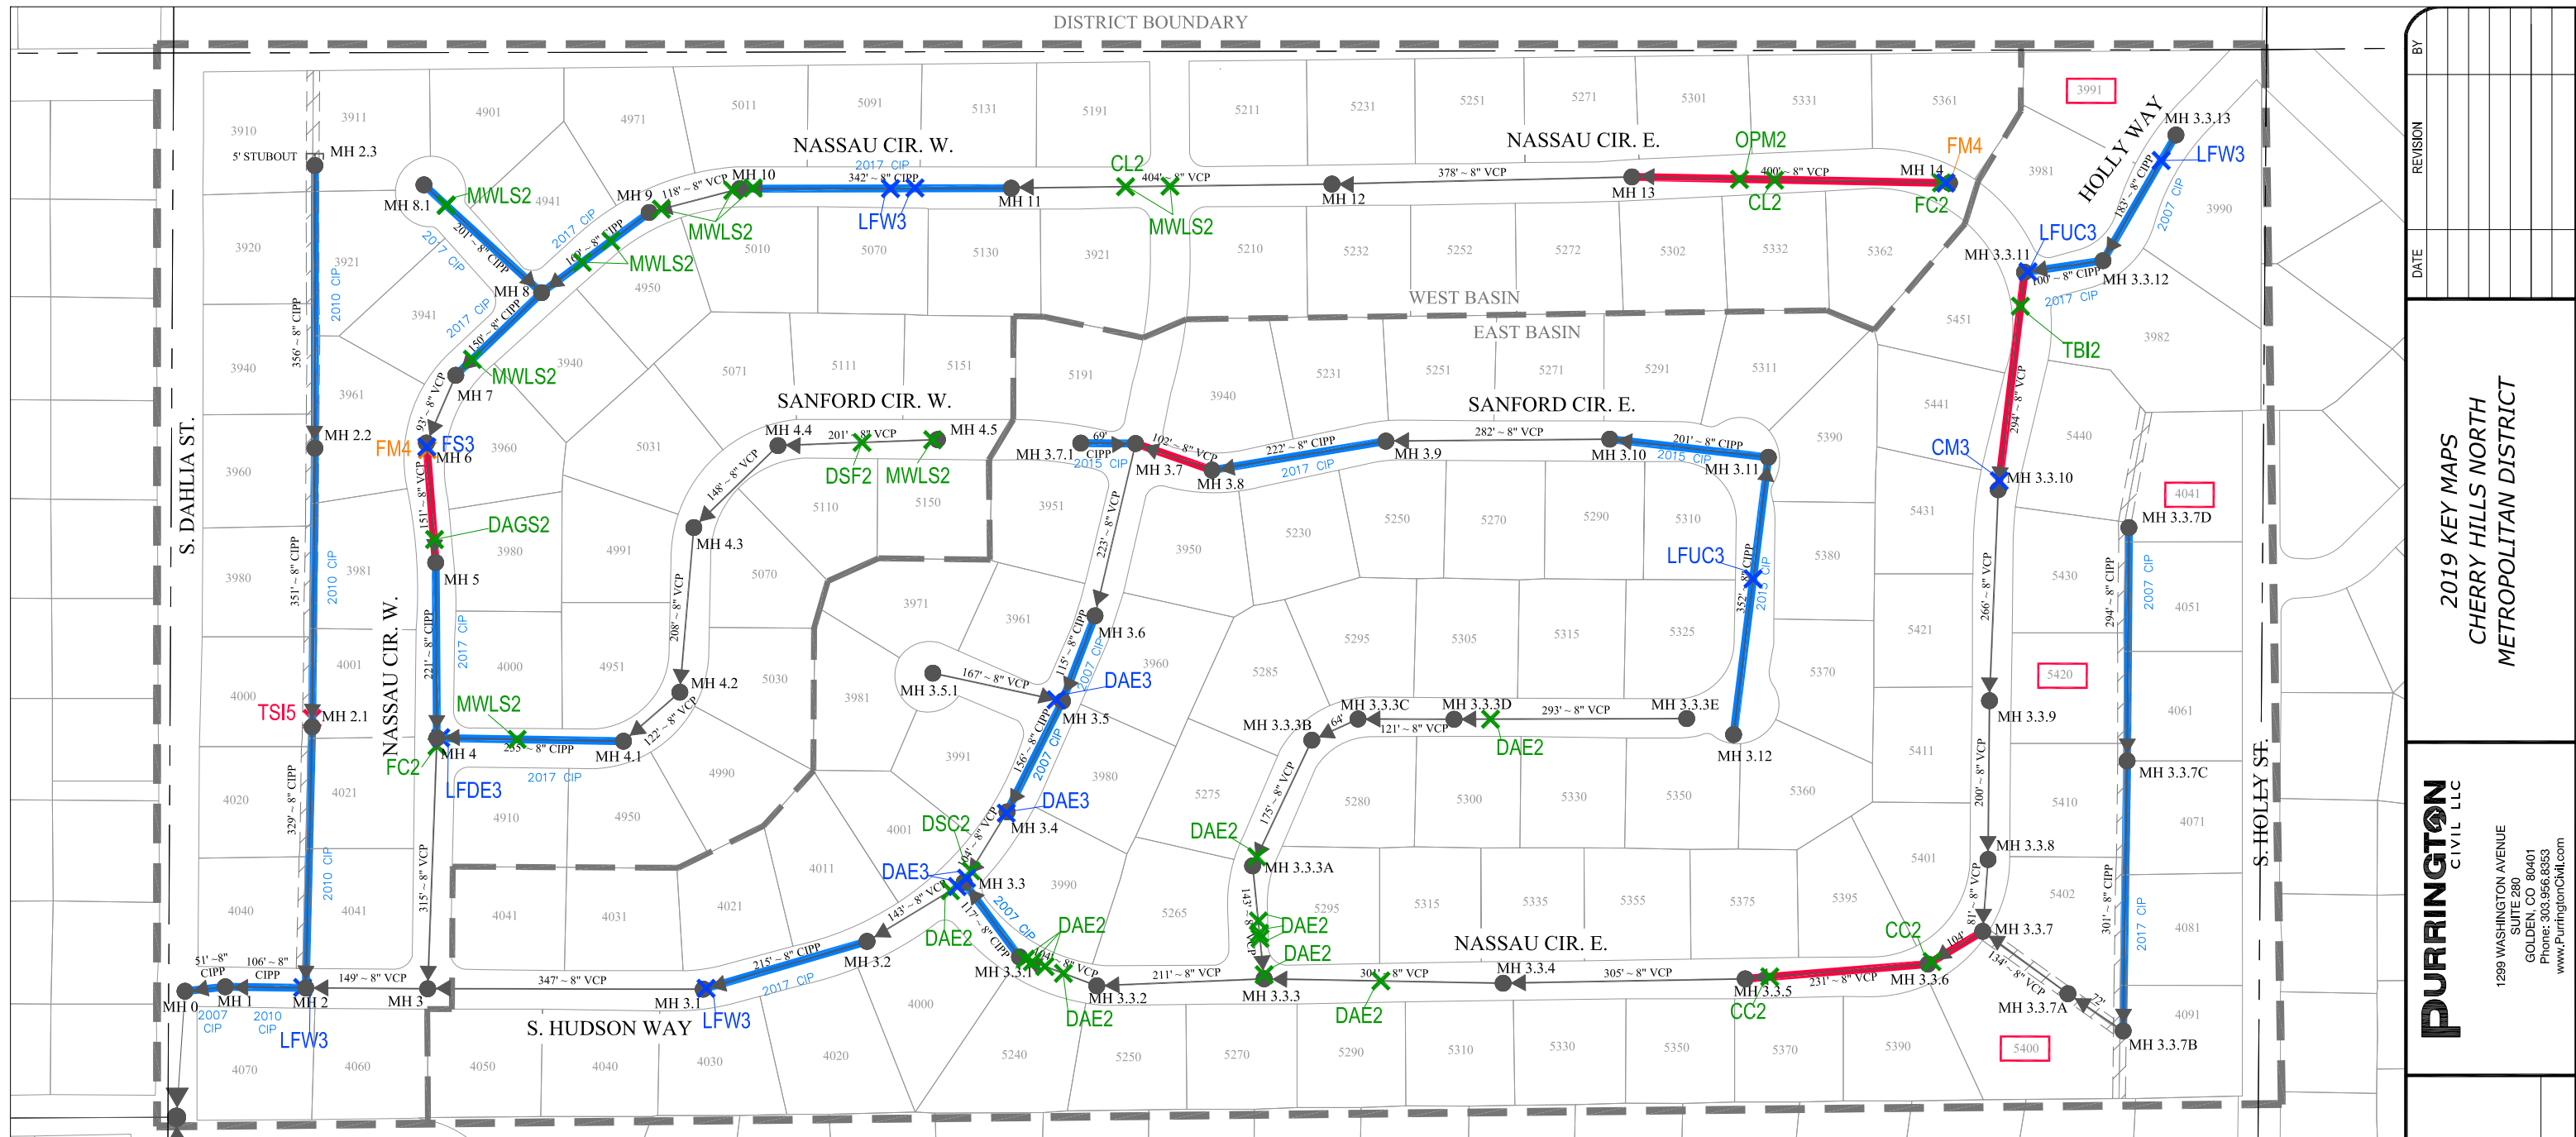
DEFECTS MAP
SCALE: AS NOTED

The 2019 Video Program consisted of video inspection of the East Basin. DES completed the video inspection on January 21, 2019. Structural defects with corresponding severity are identified on the attached Pipe Defects Map.

Six (6) sewer line segments contain defects that warrant repair.

Upstream MH	Downstream MH	Street Name	Pipe Length (LF)
MH 14	MH 13	Nassau Circle East	400
MH 5	MH 6	Nassau Circle West	151
MH 3.8	MH 3.7	Sanford Circle East	102
MH 3.3.11	MH 3.3.10	Nassau Circle East	294
MH 3.3.7	MH 3.3.6	Nassau Circle East	104
MH 3.3.6	MH 3.3.5	Nassau Circle East	231
	Total LF		1,282

Cracks in these lines have progressed to a higher grade from previous inspections. However, the defects do not appear to be severe enough to cause the pipe to collapse. As a result, repairing these lines is recommended within the next 2 – 3 years. We estimate \$34 / LF for the cured-in-place place repair for a total of **\$43,600**.

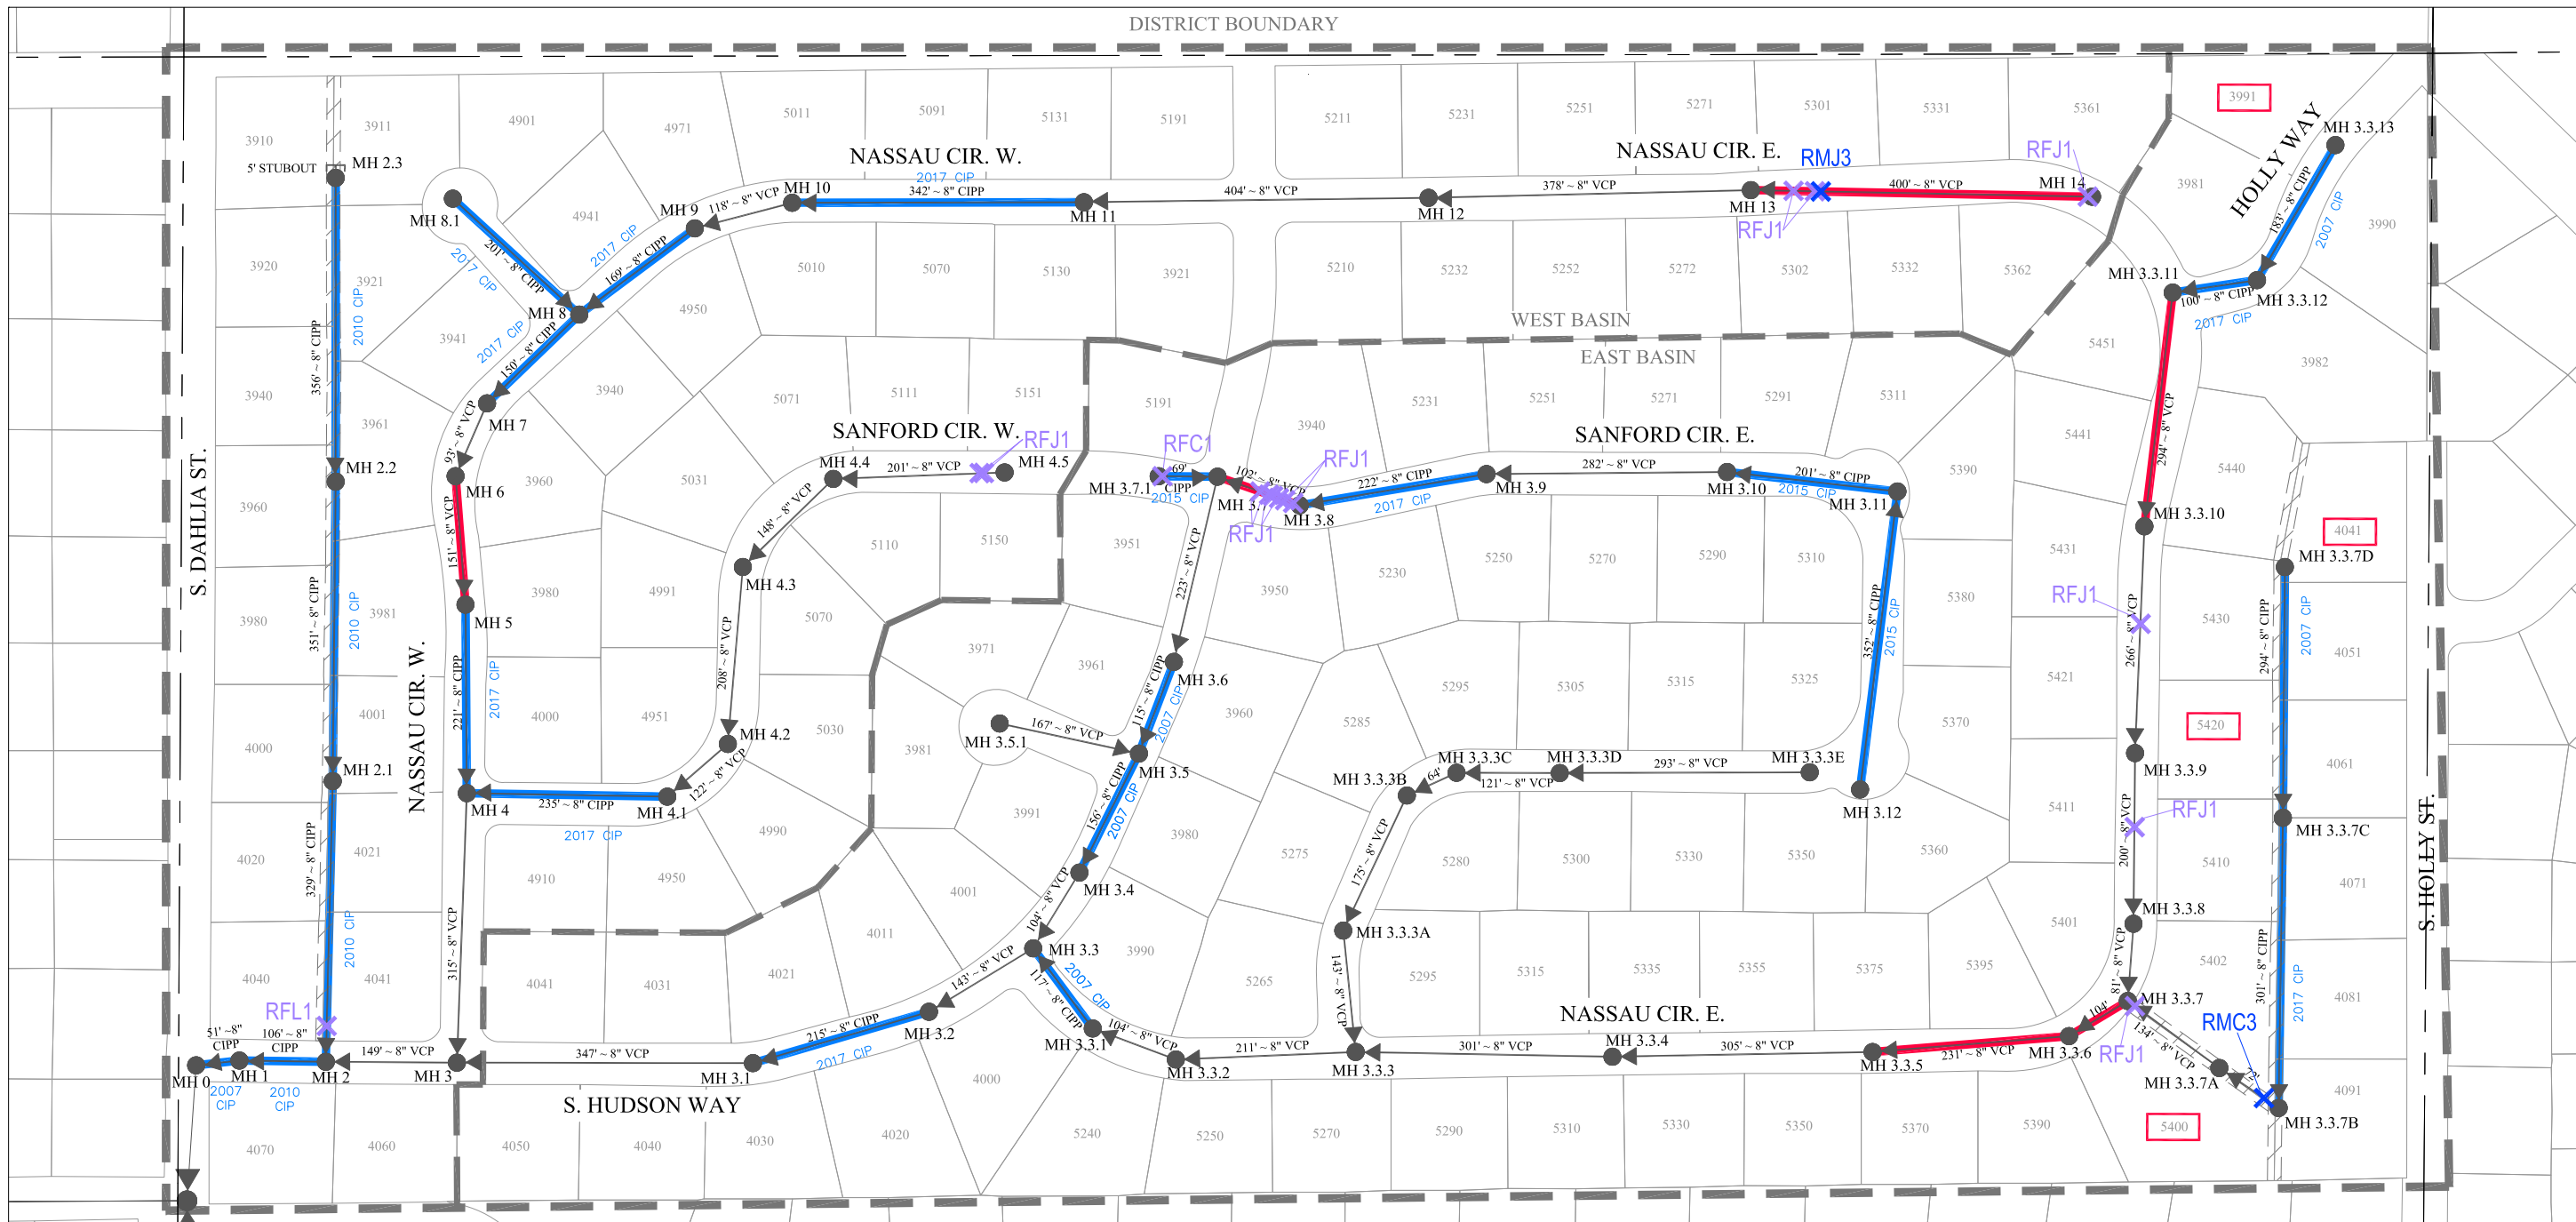
ROOTS MAP

Root removal was performed on 474 LF of main line in the East Basin. The pipe segments listed below are the lines that DES cleared of problematic roots.

Upstream MH	Downstream MH	Street Name	Pipe Length (LF)
MH 3.3.4	MH 3.3.3	5420 Nassau Circle East	300
MH 3.3.7B	MH 3.3.7A	Easement	72
MH 3.8	MH 3.7	5420 Nassau Circle East	102
	Total LF		474

Four (4) service connections with roots were identified. We recommend that letters be provided, including photos of the blocked service lines, as a courtesy to the homeowner. The addresses with root blockage are listed below.

Service Line Addresses
4041 South Holly Street
5420 Nassau Circle East
5400 Nassau Circle East
3991 Holly Way
