MEMORANDUM

To: Board of Directors
Cherry Hills North Metropolitan District

Re: 2022 Sanitary Sewer Maintenance Program

2022 SANITARY SEWER MAINTENANCE

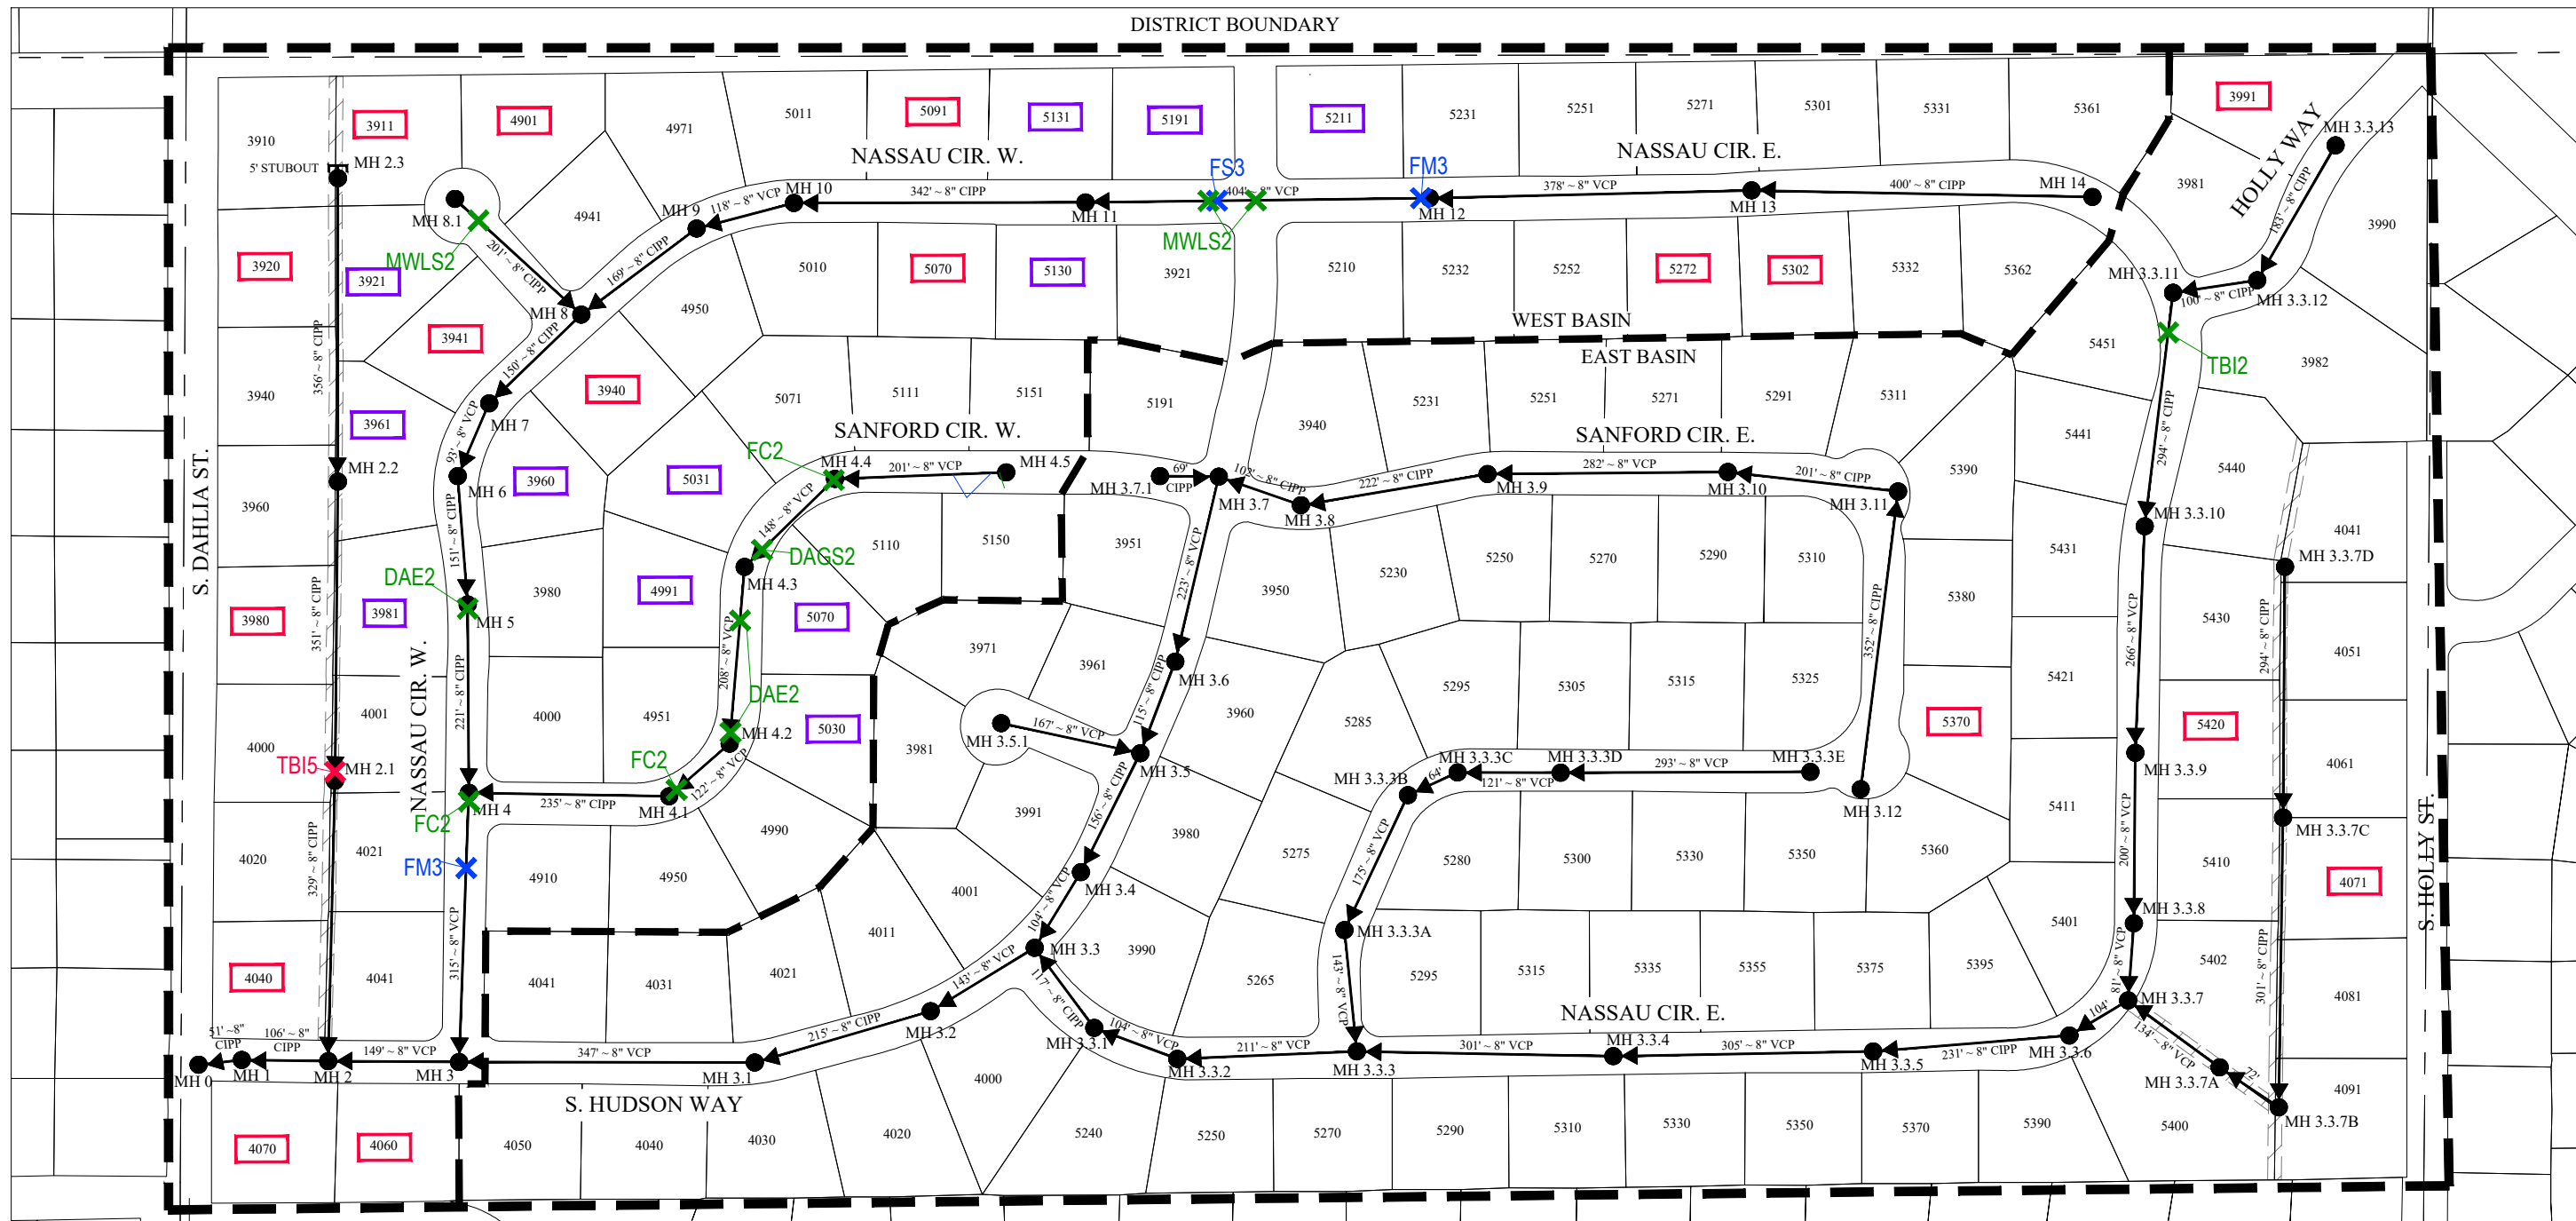
2022 DEFECTS MAP
SCALE: AS NOTED

- **Defective Service Lines**

Twelve (12) service connections with defects were identified. These defects can be repaired through top hat repairs. The addresses with defects are listed below.

- **Pipe Repairs**

Based on our review, we've identified two (2) segments of main line with fractures. We recommend these segments be added to a future CIPP repair schedule.

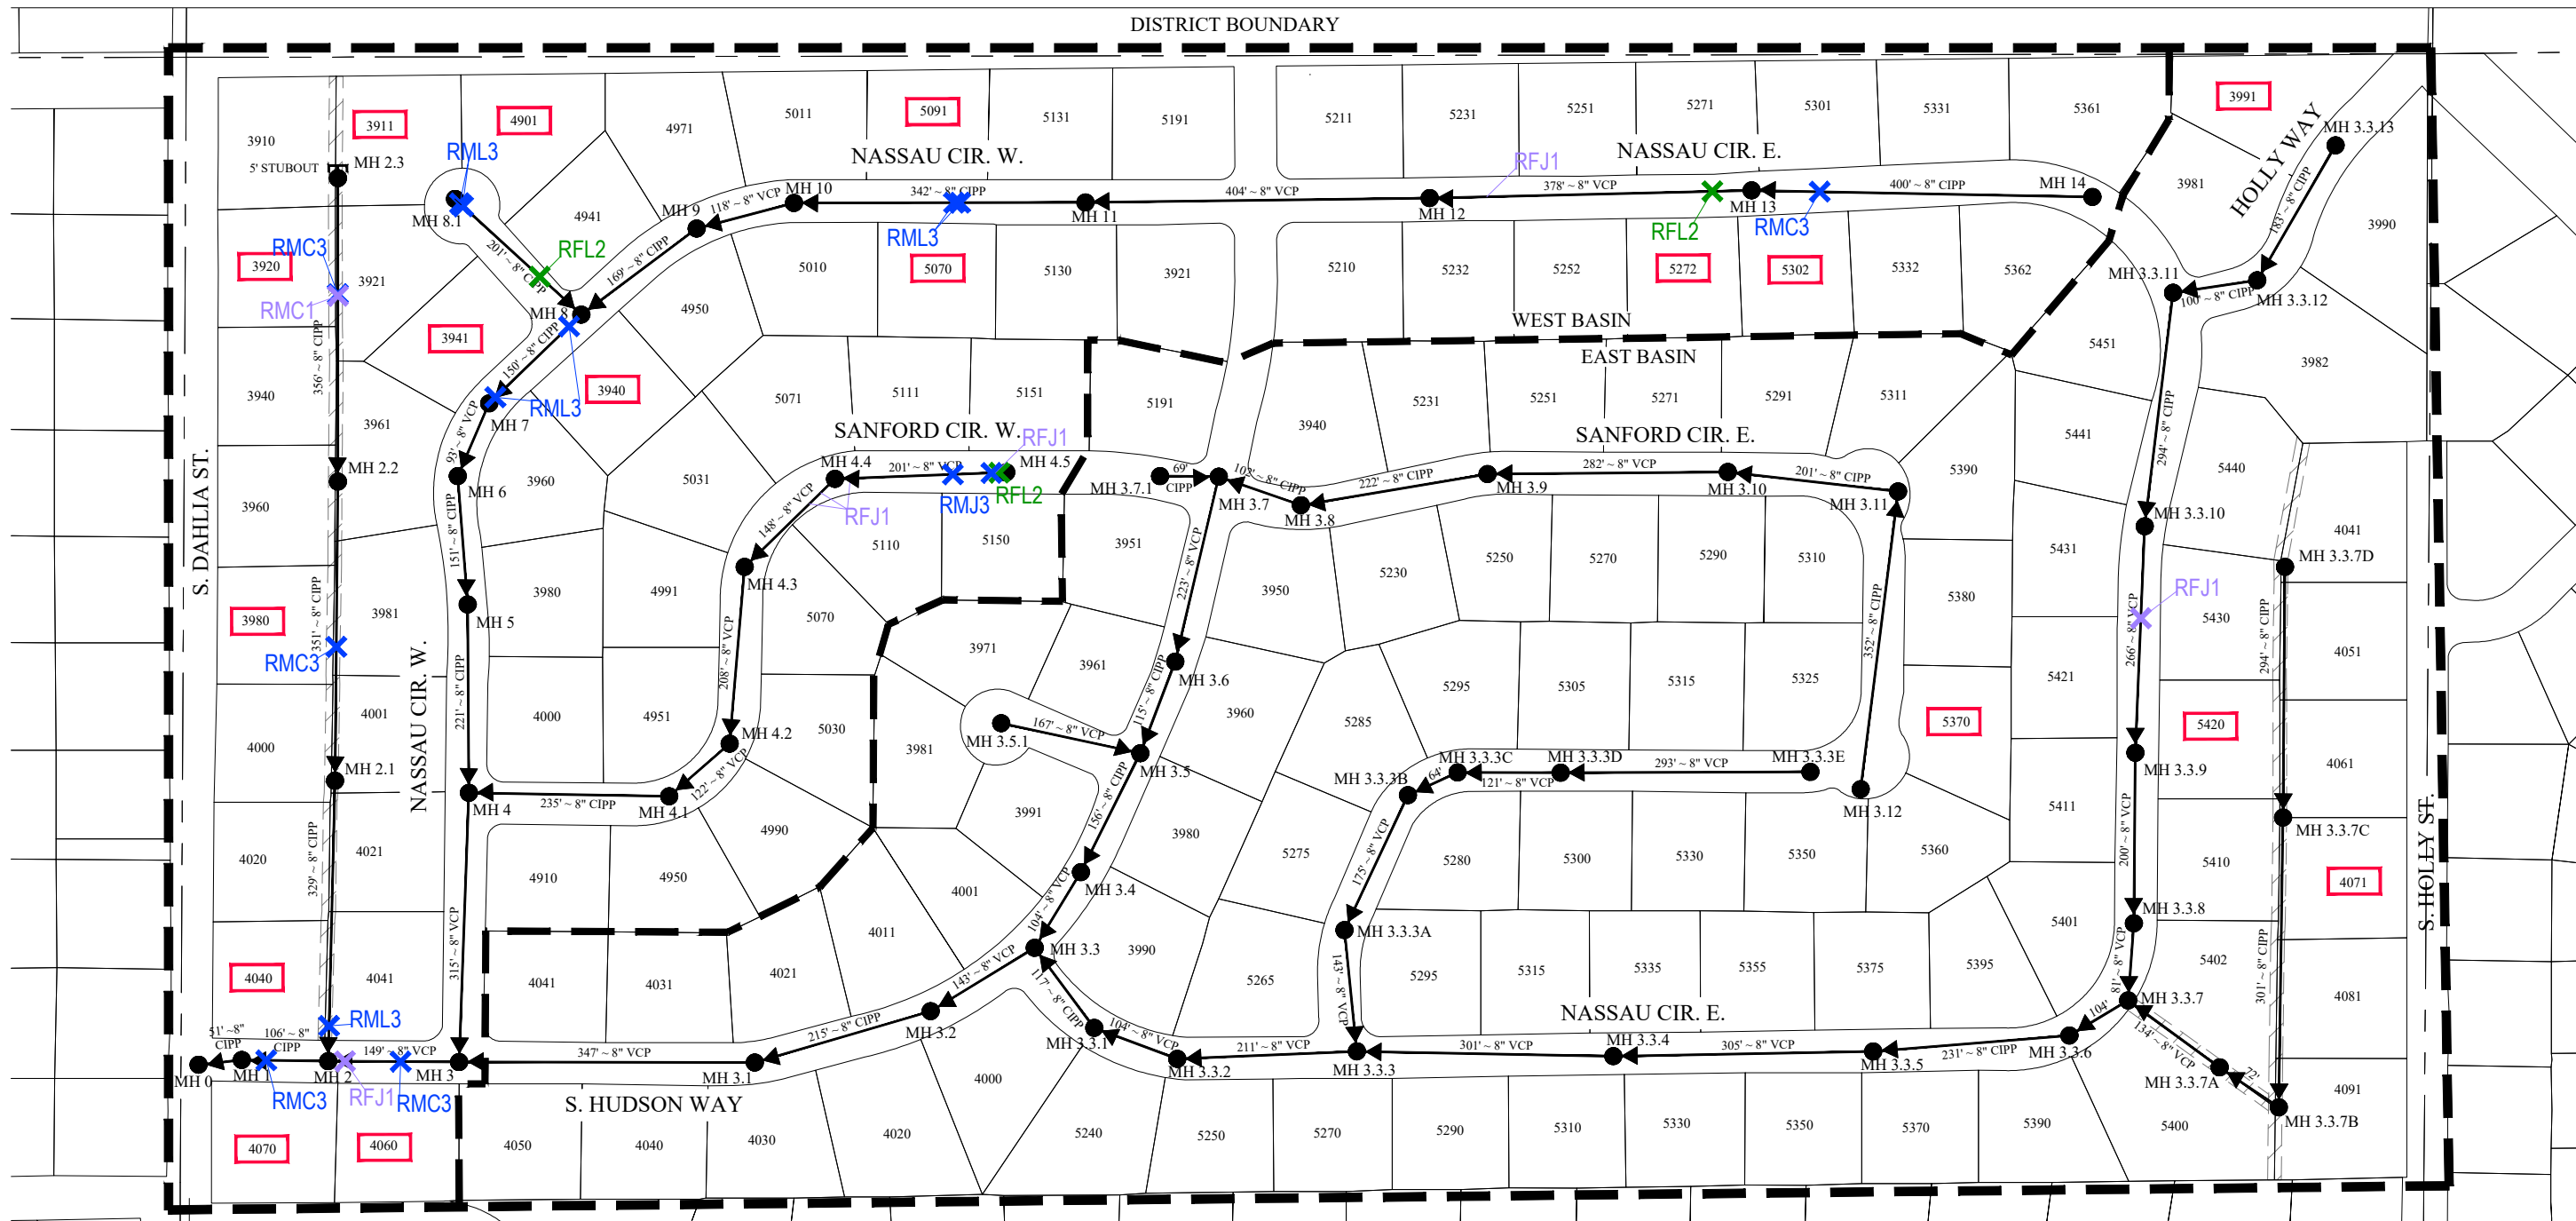
- **Roots**

Roots were minimal and no lines in this Basin required root cutting.

- **Roots in Service Lines**

Thirteen (13) service connections with roots were identified. We recommend that letters be provided, including photos of the blocked service lines, as a courtesy to the homeowner. The addresses with root blockage are listed below.
