MEMORANDUM

To: Board of Directors
Cherry Hills North Metropolitan District

Re: 2019 Sanitary Sewer Maintenance Program

2018 SANITARY SEWER MAINTENANCE

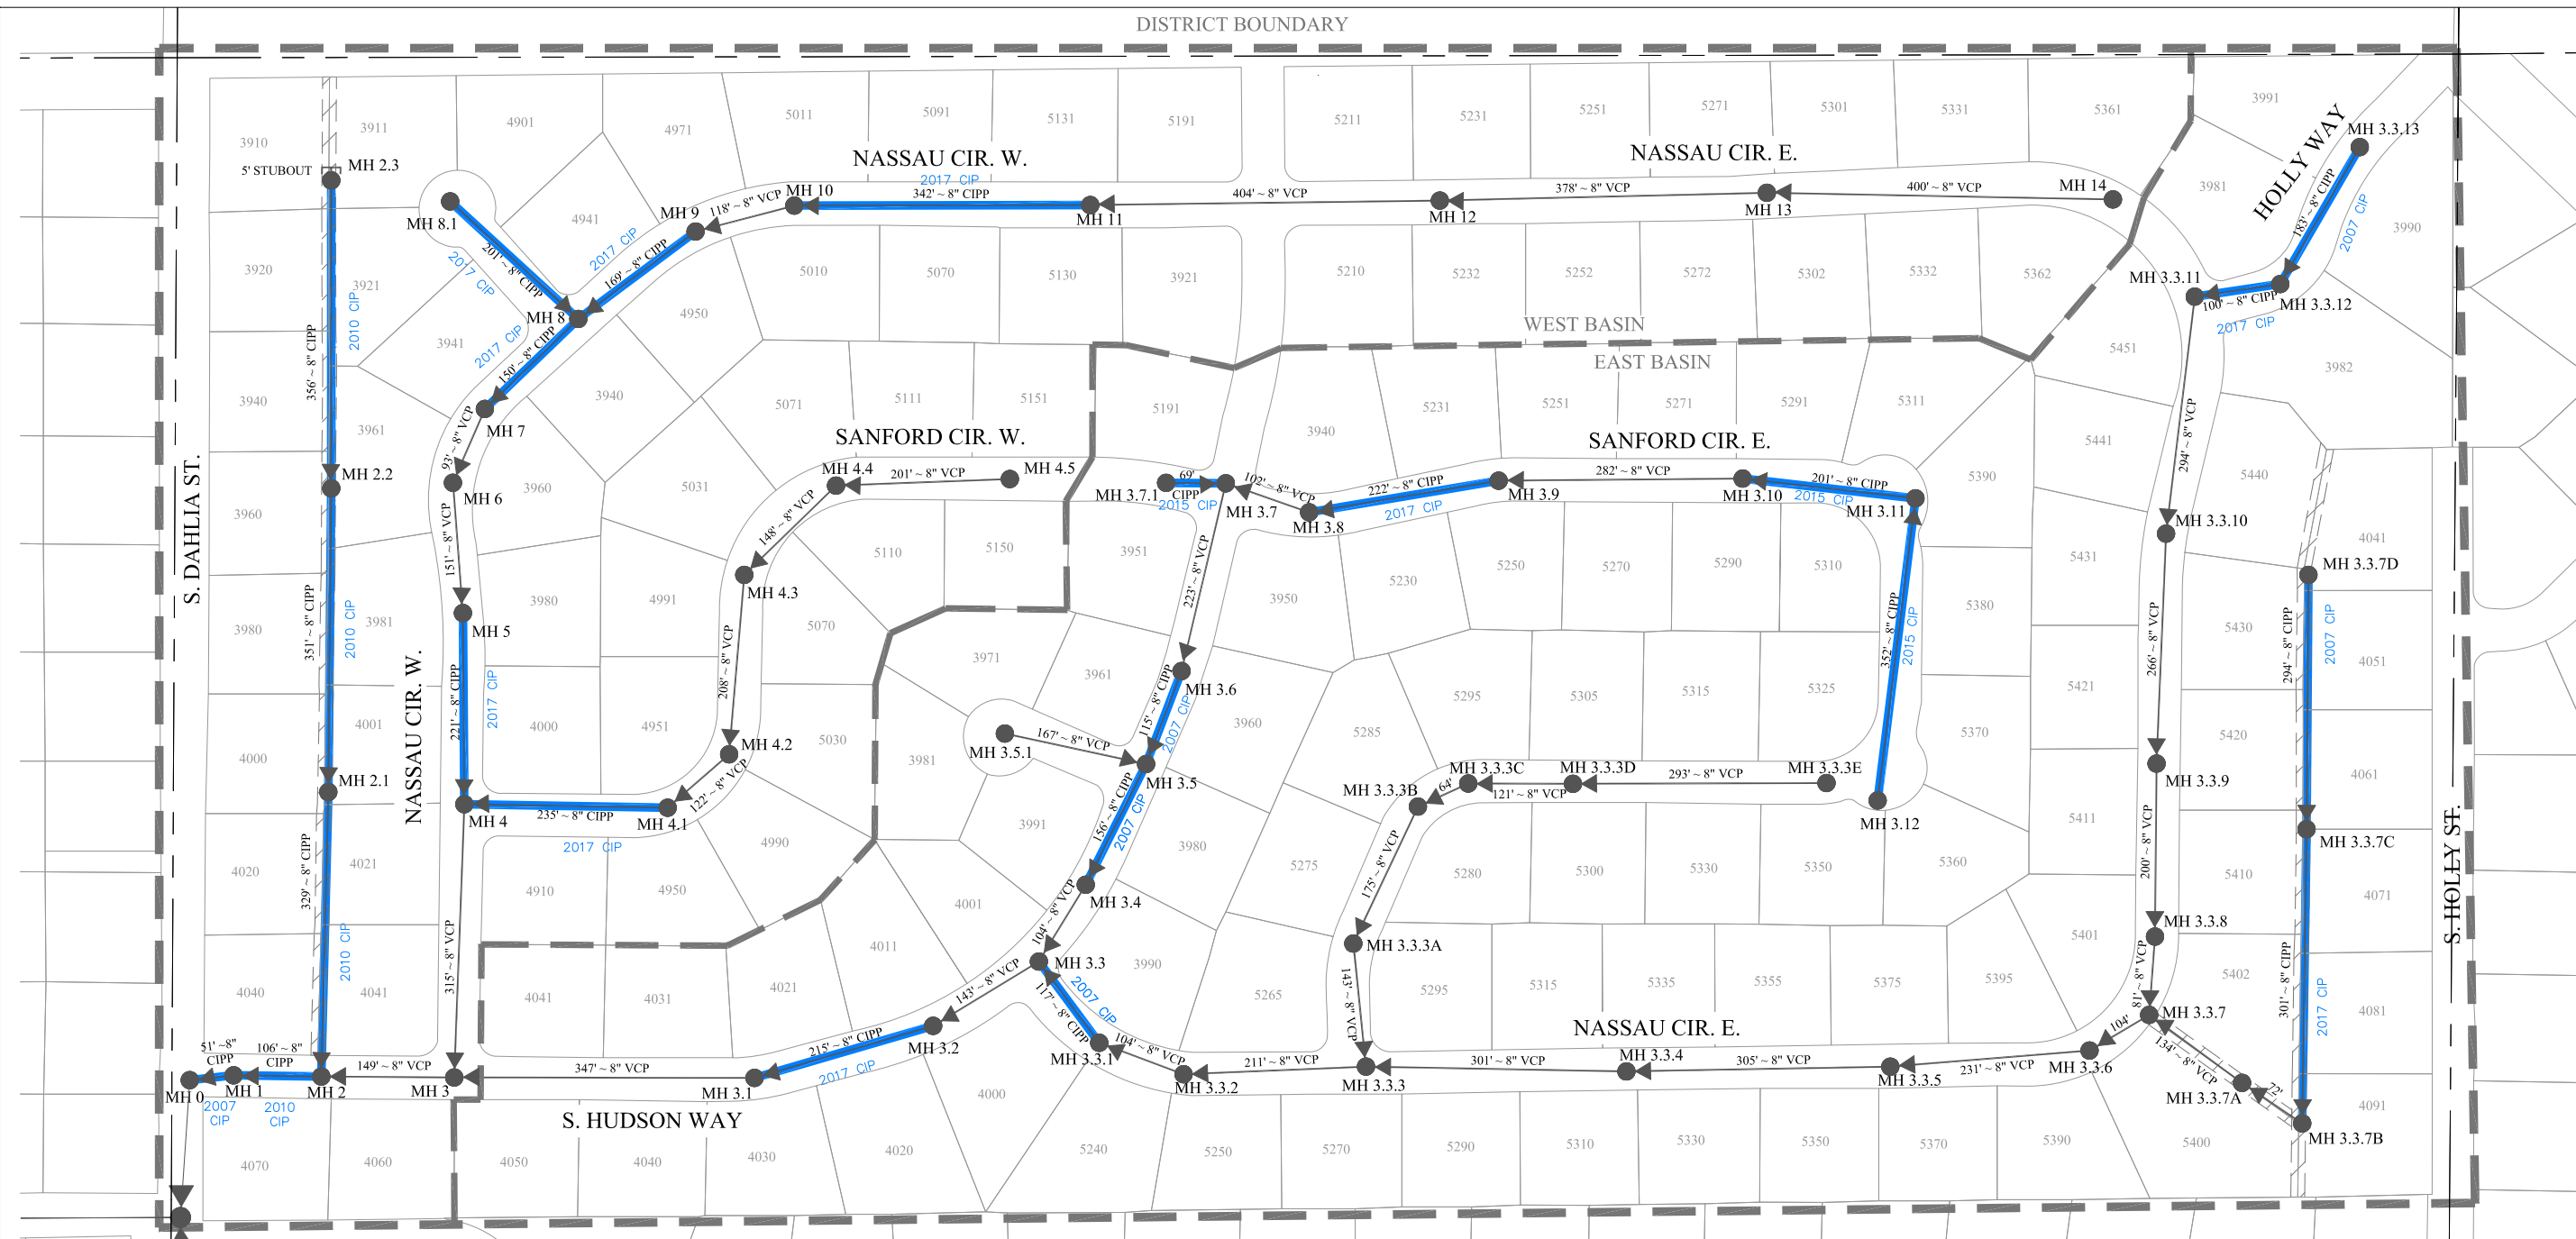
ROOTS MAP

Root removal was performed on 474 LF of main line in the East Basin. The pipe segments listed below are the lines that DES cleared of problematic roots.

Four (4) service connections with roots were identified. We recommend that letters be provided, including photos of the blocked service lines, as a courtesy to the homeowner. The addresses with root blockage are listed below.
