CHERRY HILLS NORTH  
METROPOLITAN  
DISTRICT

PIPE CONDITION
DEFECTS MAP
SCALE: AS NOTED

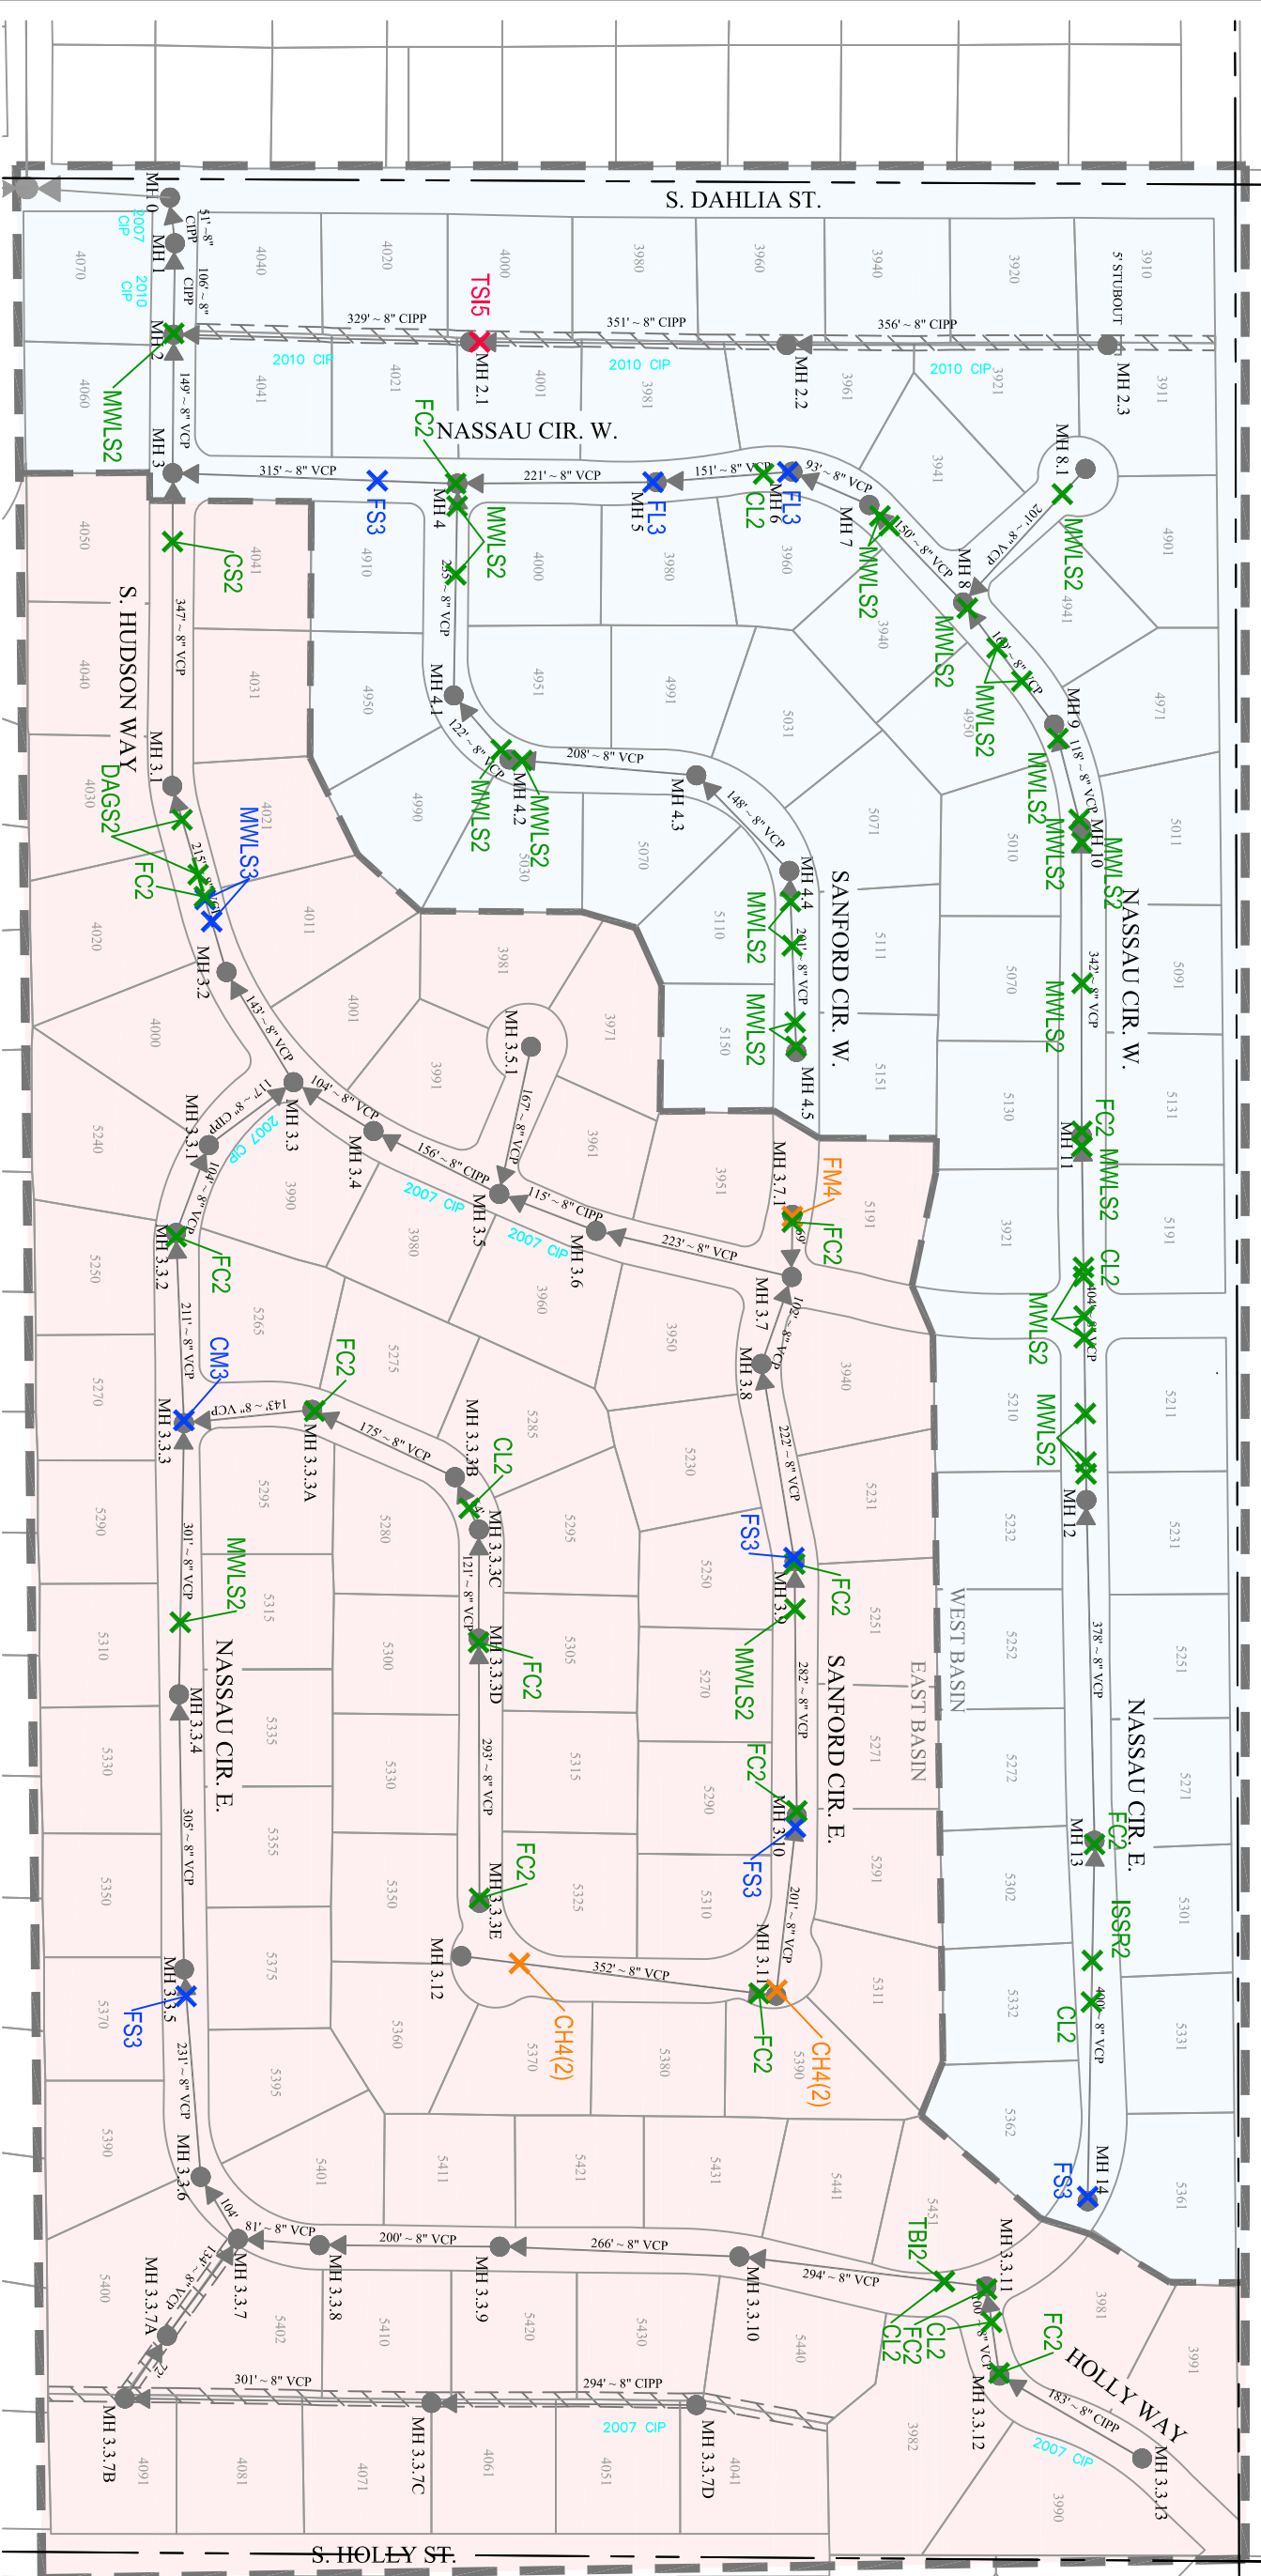
CODE	DESCRIPTION
CH(#)	CRACK HINGE (# OF CRACKS)
CL	CRACK LONGITUDINAL
CM	CRACK MULTIPLE
CS	CRACK SPIRAL
DH	DEFORMED HORIZONTALLY
DAE	DEPOSITS ATTACHED ENCRUSTATION
DAGS	DEPOSITS ATTACHED GREASE
DSF	DEPOSITS SETTLED FINE
E	ENCRUSTATION
ISSR	INTRUDING SEALING RING
FC	FRACTURE CIRCUMFERENTIAL
FL	FRACTURE LONGITUDINAL
FM	FRACTURE MULTIPLE
FS	FRACTURE SPIRAL
JOL	JOINT OFFSET LARGE
LFW	LINING FEATURES WRINKLED
MMWLS	MISC WATER LEVEL SAG
MMW	MISC WATER MARK
TBI	TAP BREAK-IN INTRUDING
TSJ	TAP SADDLE INTRUDING

STRUCTURAL GRADE	DESCRIPTION
1	MINOR (NOT SHOWN)
2	MINOR TO MODERATE
3	MODERATE
4	SIGNIFICANT
5	MOST SIGNIFICANT

CODE	DESCRIPTION
FC2	FRACTURE CIRCUMFERENTIAL
FC3	FRACTURE LONGITUDINAL

VIDEO PROGRAM	YEAR RECORDED
<span style="background-color: #f0f0f0; border: 1px solid black; display: inline-block; width: 20px; height: 10px;"></span>	2015
<span style="background-color: #e0e0e0; border: 1px solid black; display: inline-block; width: 20px; height: 10px;"></span>	2014
